Snohomish County

South Warm Beach Master Drainage Plan

Executive Summary

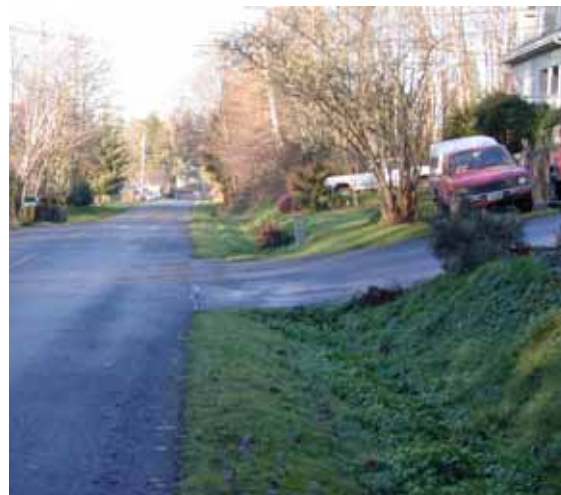
Typical roadside ditch and culvert system in South Warm Beach residential area (Clarence Ave)

In between Lake Martha Creek and Greenwood Creek, several local drainage systems have been constructed to collect runoff from neighborhoods at the west end of the study area near Puget Sound. Most of these systems consist of roadside ditches and culverts along with some enclosed drainage pipes as well. Two of the more recent developments have installed underground detention pipes. The first one was constructed in 1995 as part of a re-plat for the Giles trail permit (T-0062) and is located at the end of 95th Avenue NW just north of 192nd Street NW. The other one was

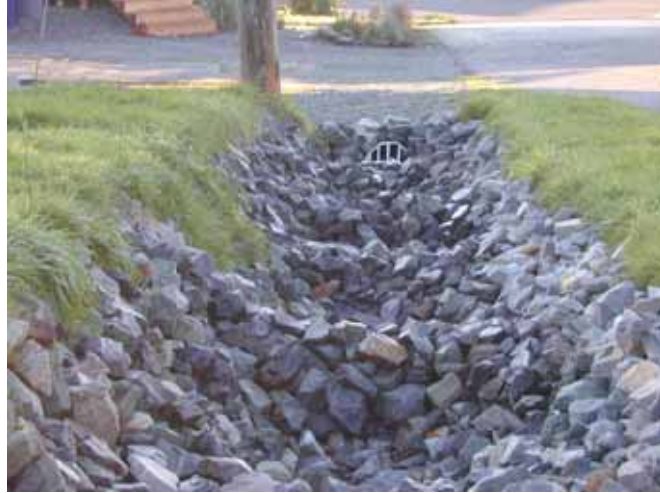
Project WB-M3-03 - Channel improvements and pipe inlet installed by the County in 2004 along 192nd Street NW

During the course of conducting this study, the Surface Water Management Division of the Public Works Department at Snohomish County had funding available to construct one of the projects in the South Warm Beach study area. County staff chose to implement project WB-M3-03, which addressed the identified flooding problems along 192nd Street NW by upgrading the existing drainage system. During the final design of this project, the scope of the project was expanded to extend the culvert further downstream and to install upstream channel improvements (see photo). These improvements were completed by County road maintenance crews in 2004. The total cost of the project, including design and permits, was approximately \$64,000, which is higher than the planning level cost estimate of \$48,000 that was prepared for this study. This difference in cost was partly due to the need to conduct archeological monitoring during construction of the project and partly due to the slightly expanded scope of the project.

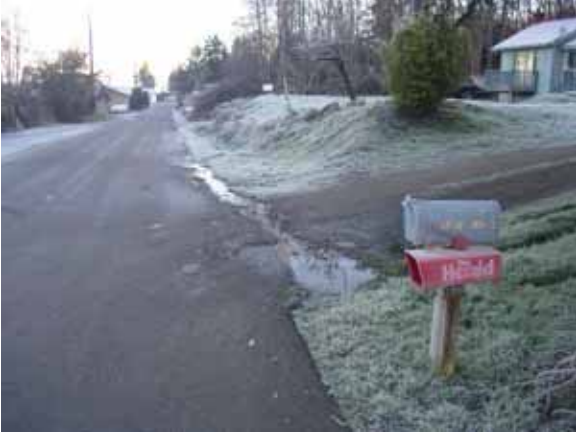
98th Ave NW Before Maintenance: Surface water flowing around buried culvert and downstream section of filled ditch

At 98th Avenue NW, County maintenance crews in 2006 cleaned the roadside ditch, replaced a buried culvert, and installed a new catch basin to help prevent flooding of a driveway and the roadway shoulder. The photographs on the following page show this drainage system before and after the maintenance was completed.

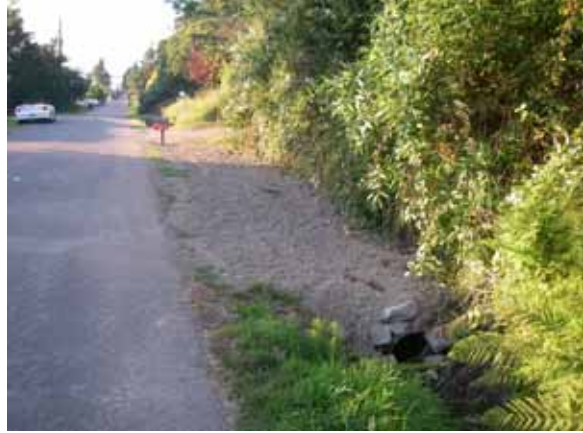
98th Ave NW After Maintenance: Ditch was excavated, buried culvert was replaced, and catch basin was installed
